Observation report for environmental, social and health safety compliance of Four Solar Irrigation Project (Operational)

Project Name: Chapri (Pump-1 & 2), Union- Purahati, Jhenaidah Sadar, Jhenaidah district.

Project Name: Hordebpur (project:1 & 2), Union-Jamal, Kaliganj upazilla, Jhenaidah district.
Implemented by **Action In Development (AID)**

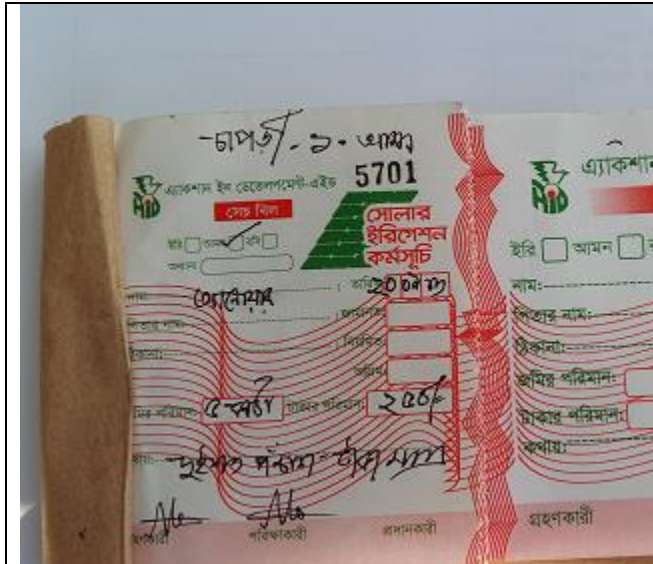
Figure 5: Payment method

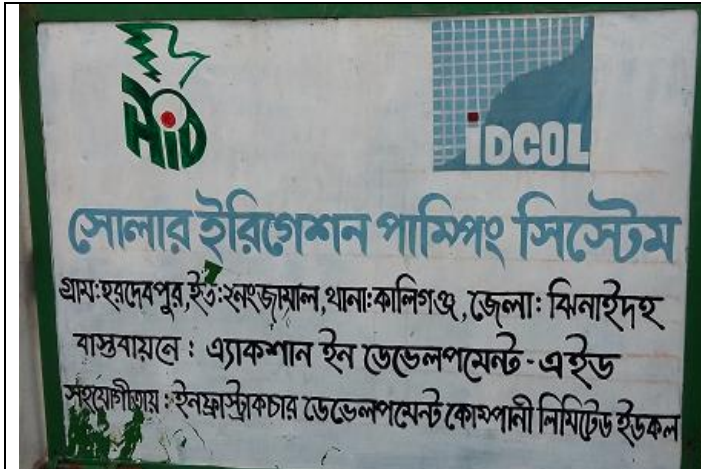
Figure 1: Projects' signage

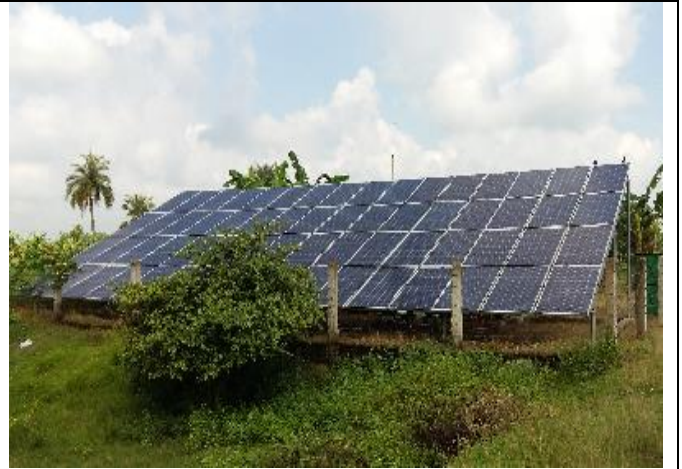
Figure 2: Solar panel

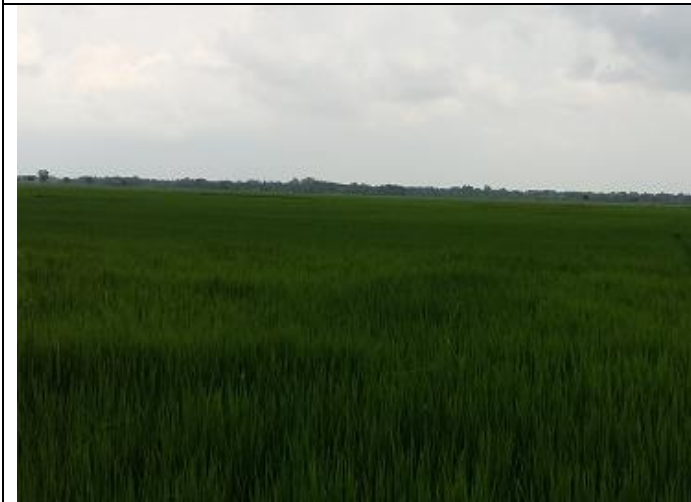
Figure 3: Water served into the agriculture field

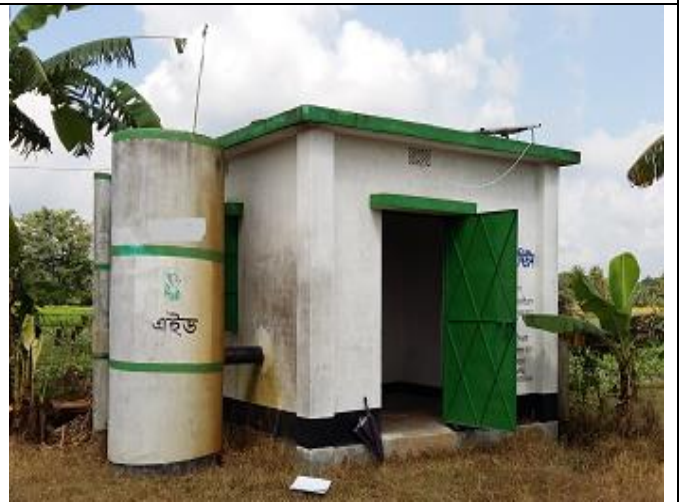
Figure 4: Pump room & Reservoir tanker

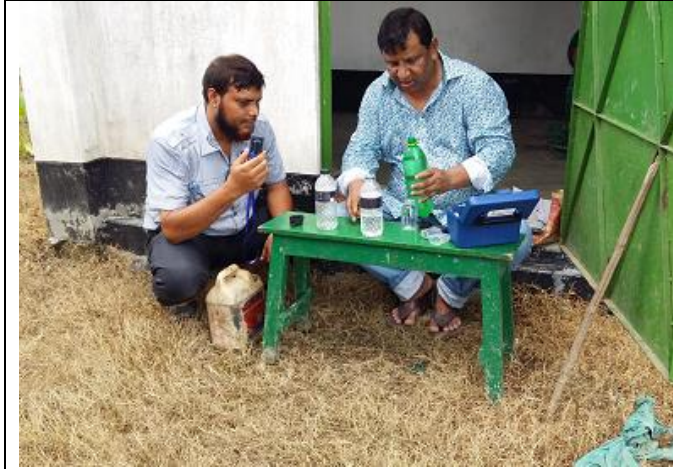
Figure 1: pH testing at Chapri (1&2)

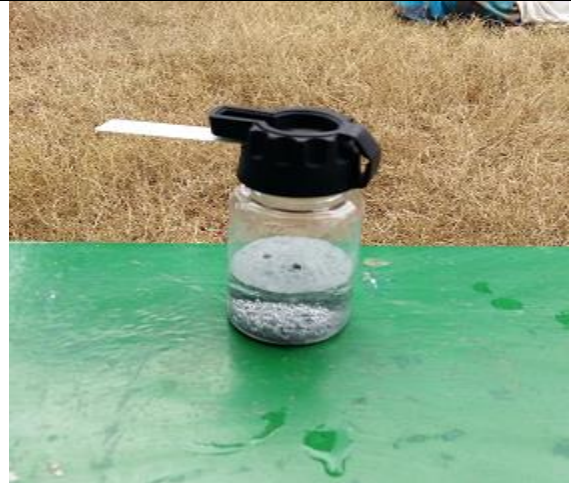
Figure 2: Arsenic test at Chapri (1&2)

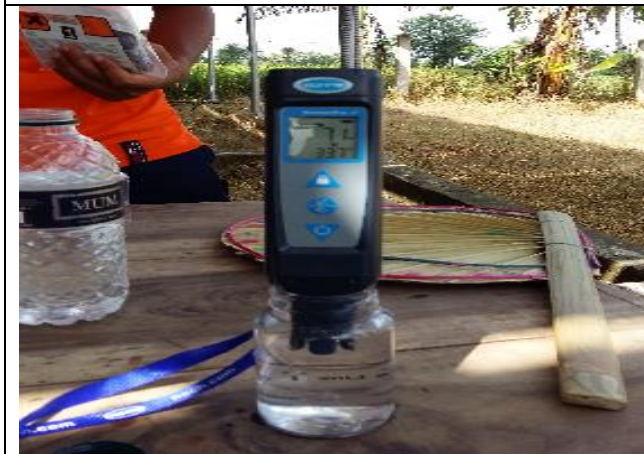
Figure 3: pH testing at Hordebpur (project:1 & 2)

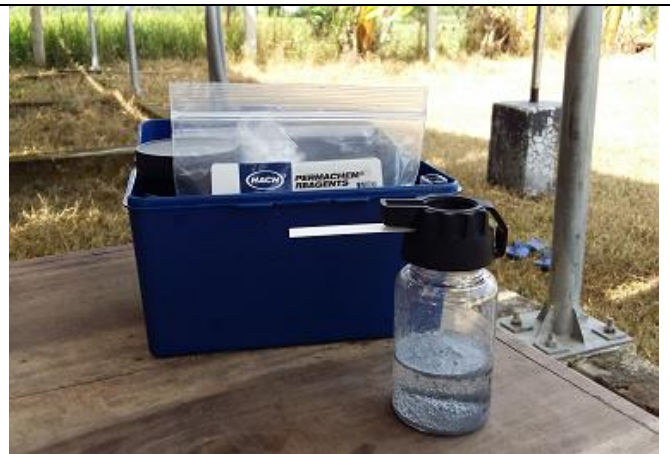
Figure 4: Arsenic testing at Hordebpur (project:1 & 2)
